Manhole Inspection Summary

Manhole # S23K__018MH

Insp Date: **6/10/08 1:03 PM**

Location Address: **335 Parrish St**

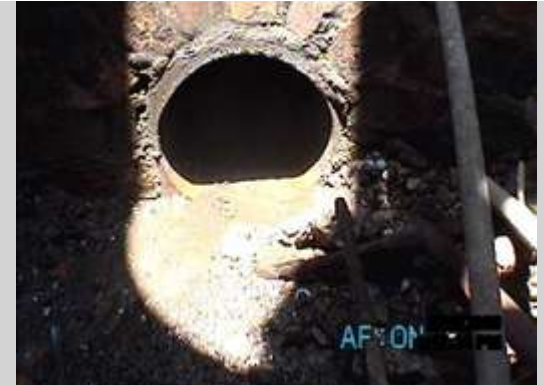
12 O'Clock Outflow

8 in. Circular Gravity Sewer
Pipe Out @ 12 O'Clock

Infiltration: **None** Pipe Seal Cond: **Sound**
